## ARIZONA DEPARTMENT OF ENVIRONMENTAL QUALITY

Re: Complaint inspection of Hickman's Egg Ranch-Arlington/North, Inspection ID: 210545

# ARIZONA DEPARTMENT OF ENVIRONMENTAL QUALITY WATER QUALITY DIVISION COMPLAINT INSPECTION

Inspection ID \_210545

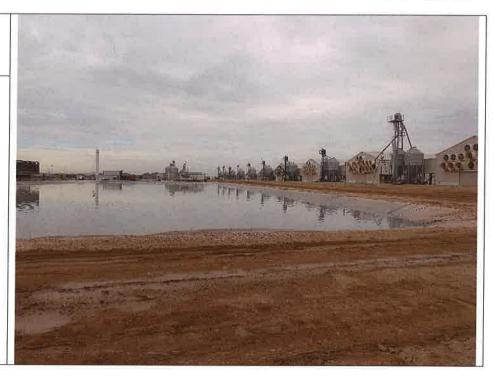
Image/Photo Number: 1

A view of the Arlington North wastewater pond. This pond is lined with 40 mil. plastic is located behind the Arlington North Processing Plant. The pond dimensions are 450 feet long by 150 feet wide, with a depth of 8 feet. All lagoons and stormwater retention basins at Hickman's are lined.

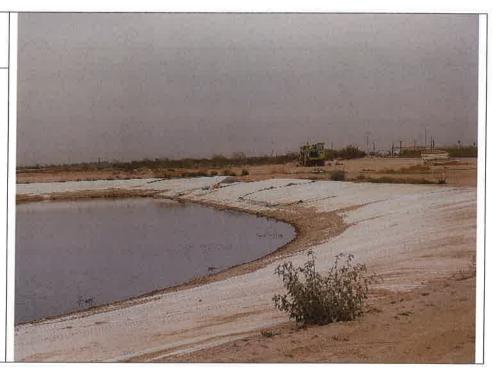
2

A view of the Arlington South wastewater pond. This pond is lined with 40 mil. plastic and is located behind the Arlington South processing plant. The pond dimensions are 250 feet long by 100 feet wide, with a depth of 6 feet. All lagoons and stormwater retention basins at Hickman's are lined.

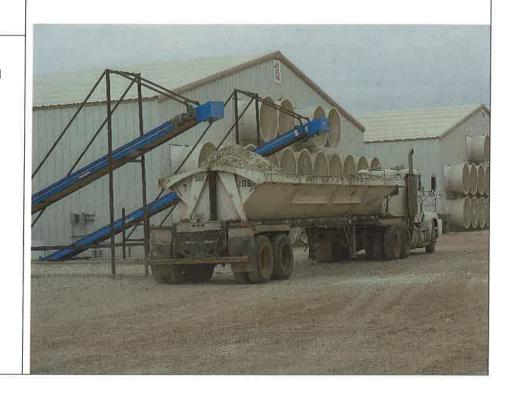
A view of manure being uploaded onto a collection vehicle. The manure is transported to the composting area for blending and placement into windrows.

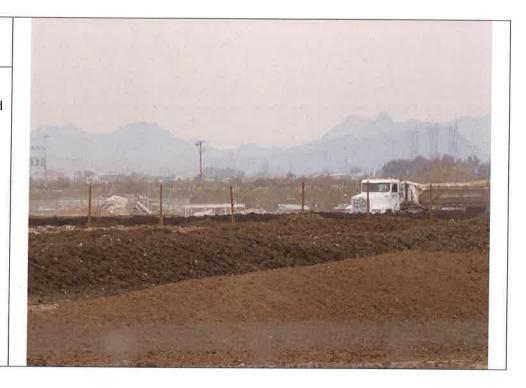
Composted manure in windrows for blending. The windrows are segregated by laying house to avoid any cross contamination.

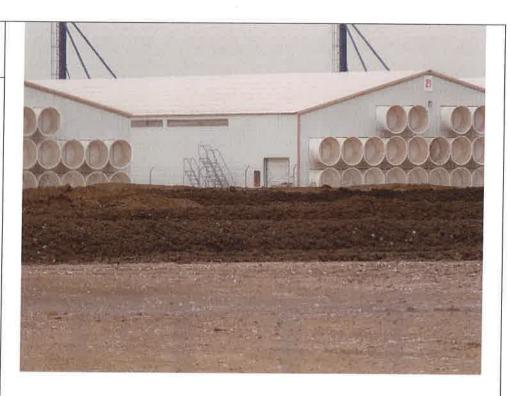
Another view of compost windrows. All manure rows are located on the Arlington North Parcel 401-30-004D. The Hickman's facility operates in compliance with the CAFO general permit and part 651 Agricultural Waste Management Field Handbook, Chapter 10 -Agricultural Waste Management Systems Component Design, Page 10-54 (6) Composting.

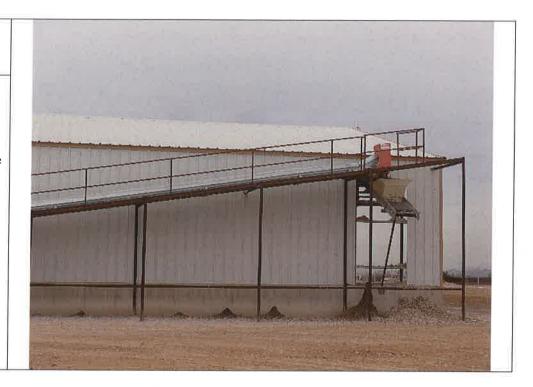
6

The new style of lay houses collect manure and deliver it via conveyor belt to the semi enclosed storage area where it is placed into indoor windrows. This material will then be transported to the compost pellet mill to be heated to remove microbes and then packaged for sale.

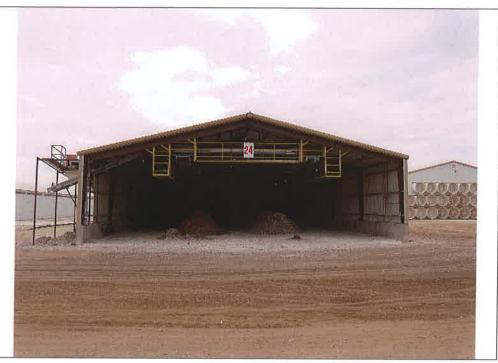
6

A view of windrowed manure enclosed in a lay house. Cement flooring prevents nitrate leaching into the soil. The manure will be delivered from the lay house windrows directly to the pellet mill for heating and final packaging.
